CONSTRUCTION SUPERVISION OF THE ASPARA-BLAGOVESHENKA  
SECTION IN ZHAMBYL OBLAST, INVESTMENT PROGRAM PROJECT4  
(ADB Loan # L2735-KAZ, CAREC Transport Corridor I)

# BIANNUAL ENVIRONMENTAL MONITORING REPORT - JUNE 2013

Project Number: 41121-053  
{July 2013}

## KAZAKHSTAN: MFF CAREC Transport Corridor 1 (Zhambyl Oblast Section) [Western Europe- Western People's Republic of China International Transit Corridor] Investment Program - Project 4

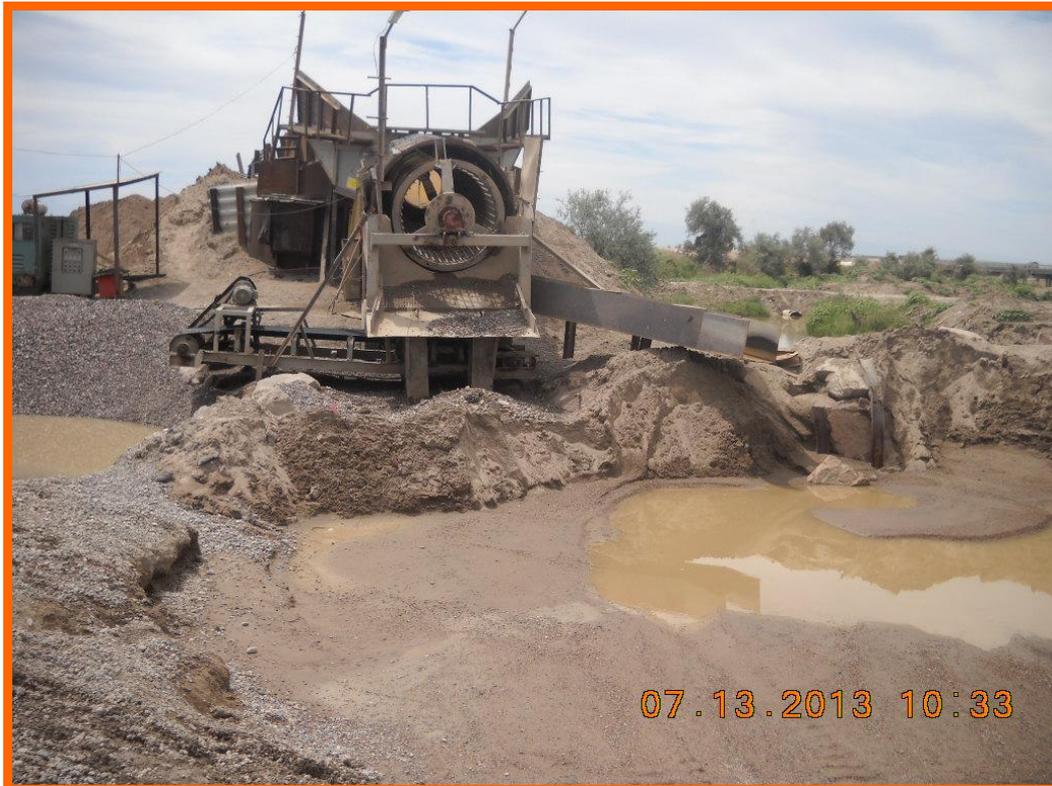
**Photo No. 1 : Gravel and sand washing equipment**

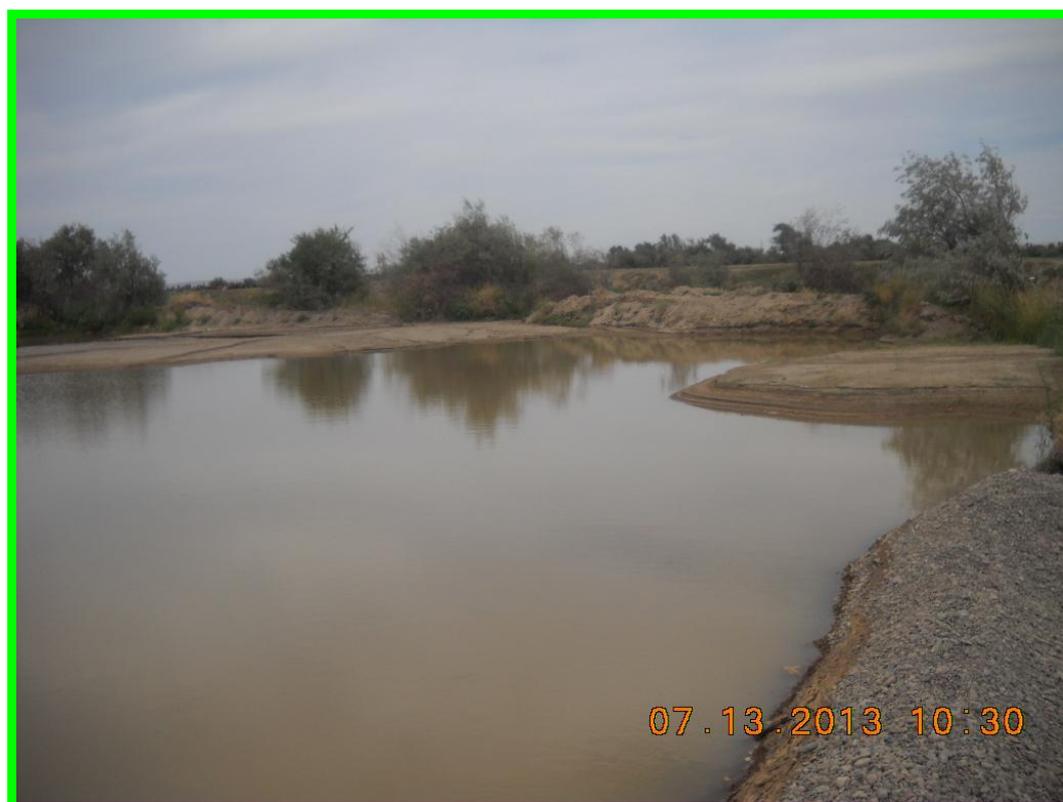
**Photo No. 2 : Current washing water containment pond**

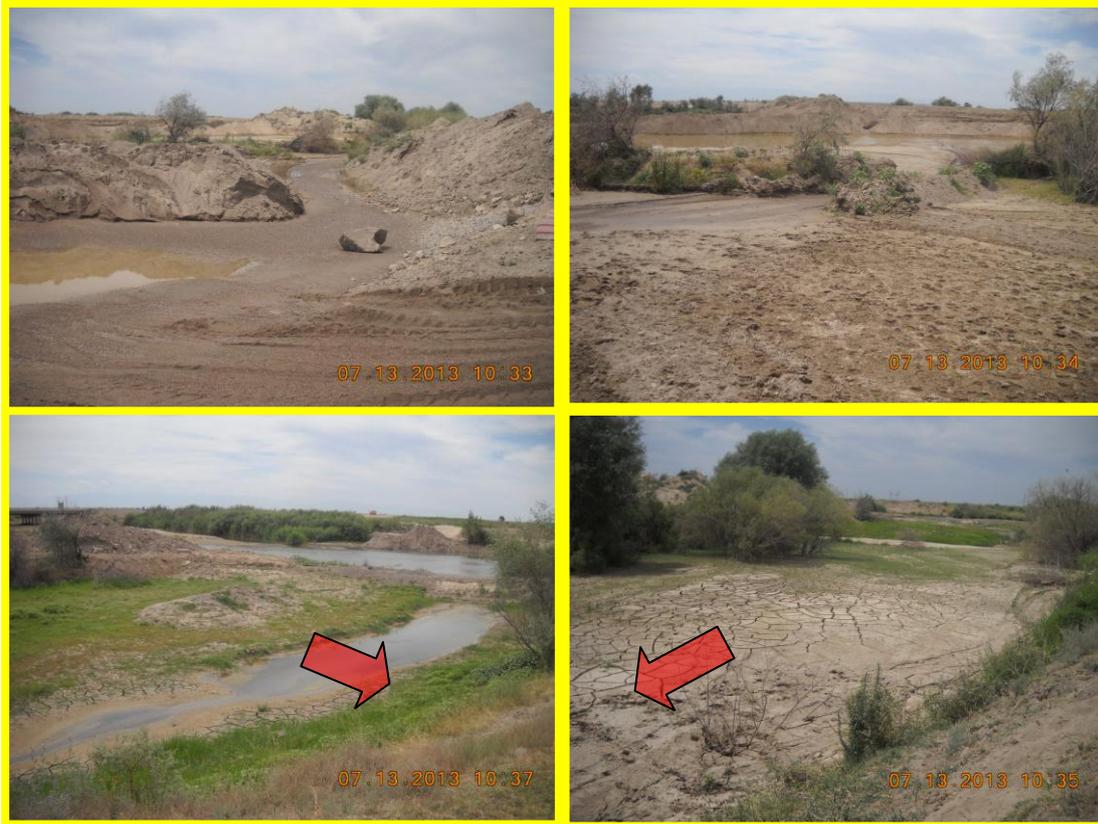
Photo No. 3 : A number of ponds were developed into siltation ponds

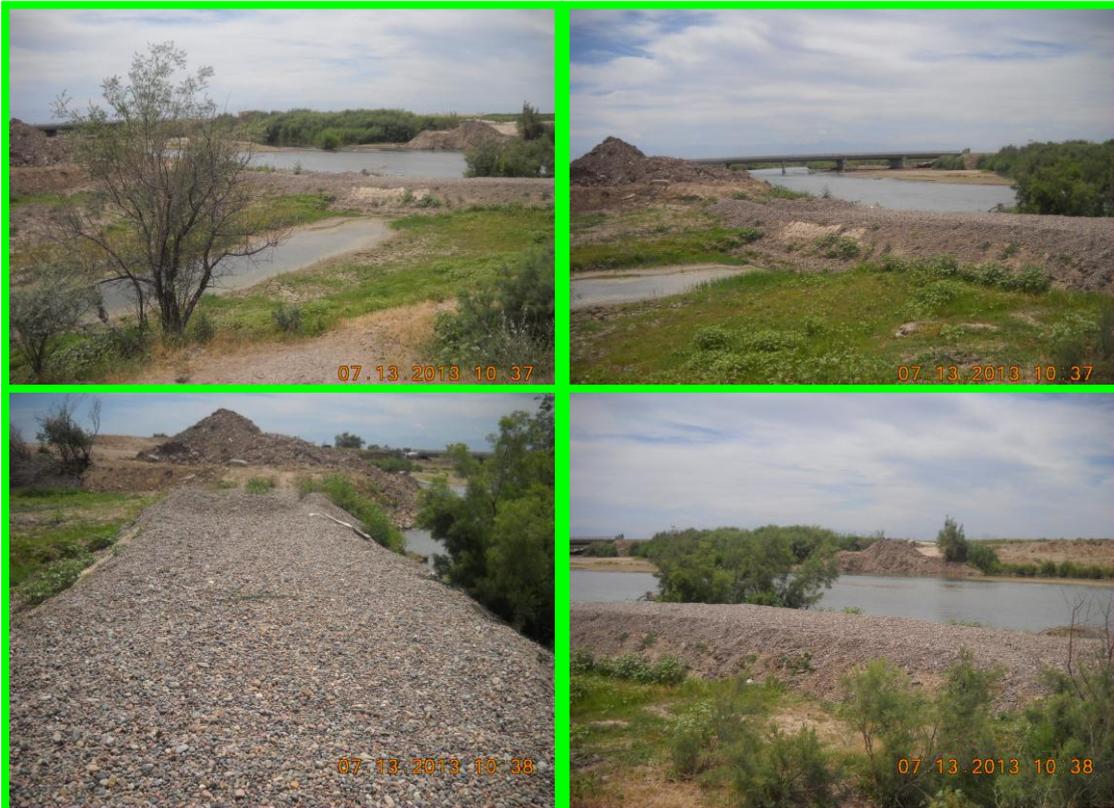
Photo No. 4 : Filter berm level was increased to function properly

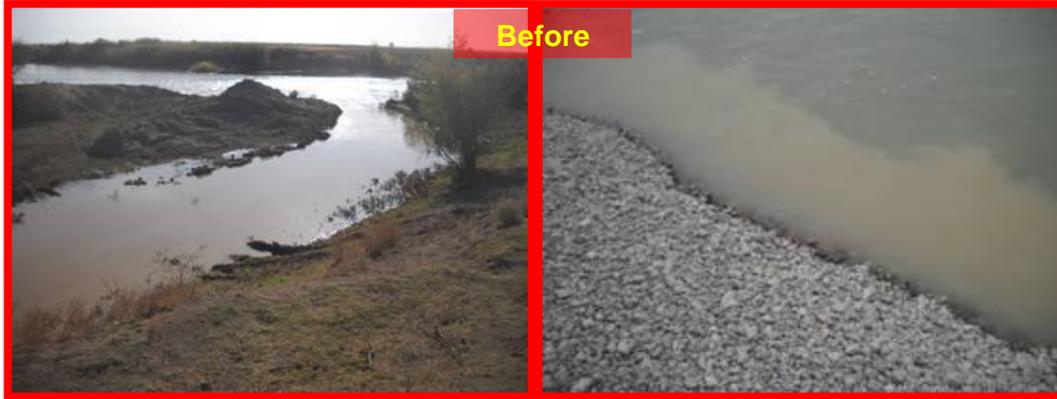
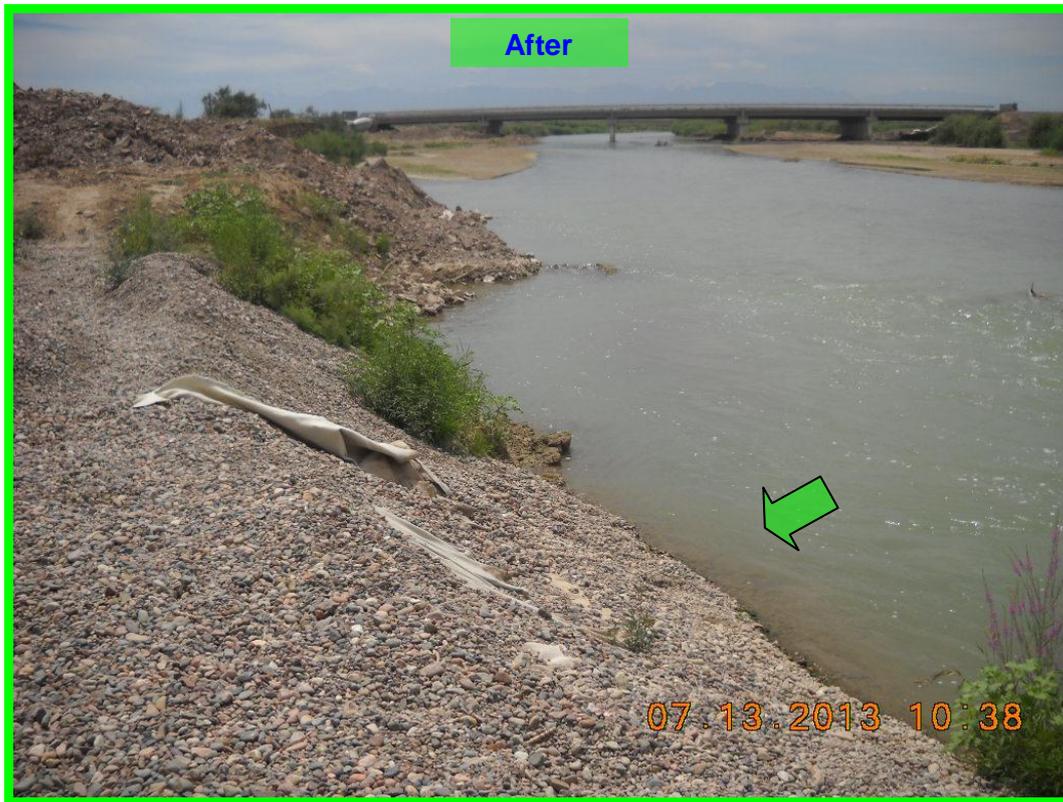
Photo No. 5 : Threat of silt contamination to Shu River was eliminated

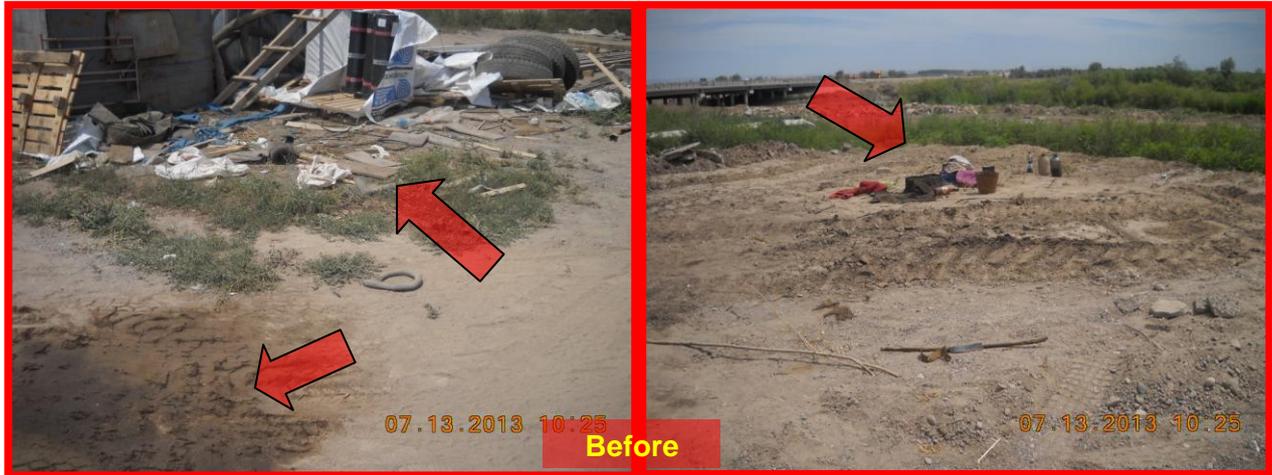
Photo No. 6 : Contamination and solid waste issues at Subcontractor's (MO-1) camp

(2) Produce the Plan for the Sequenced Usage of the Ponds	(2) Within one month
			(3) Reinstatement Plan	(3) Within 3 months
			CS Consultant: - monitor activities	Regular Inspection Days
2	<p><u>Contamination and solid waste issues at Subcontractor (MO-1) Camp</u> – During inspection, the following were observed: (1) Petroleum Contamination on the ground; (2) Uncollected garbage and dirty work camp. [Photo No. 6]</p>	<p>Sanitary conditions should be maintained at the work camps at all times.  Re-instatement of the work camps should be done by the Subcontractor prior to demobilization</p>	Contractor should ensure that camp grounds are always in sanitary conditions	Daily Monitoring
			Reinstatement should be monitored by Contractor	During and after demobilization

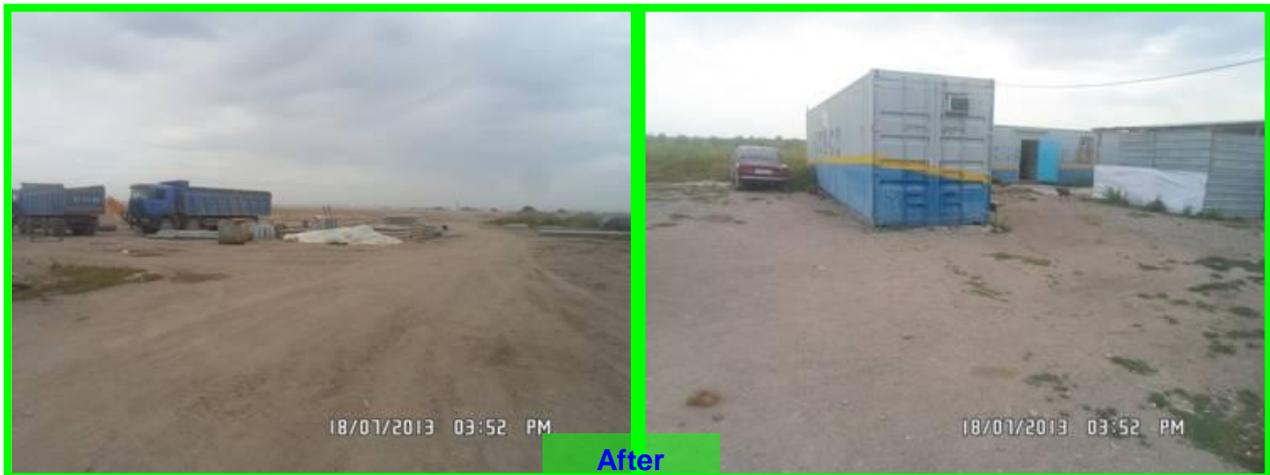
Photo No. 7 : Clearing up of camp grounds prior to Sub-Contractor's (MO-1) demobilization

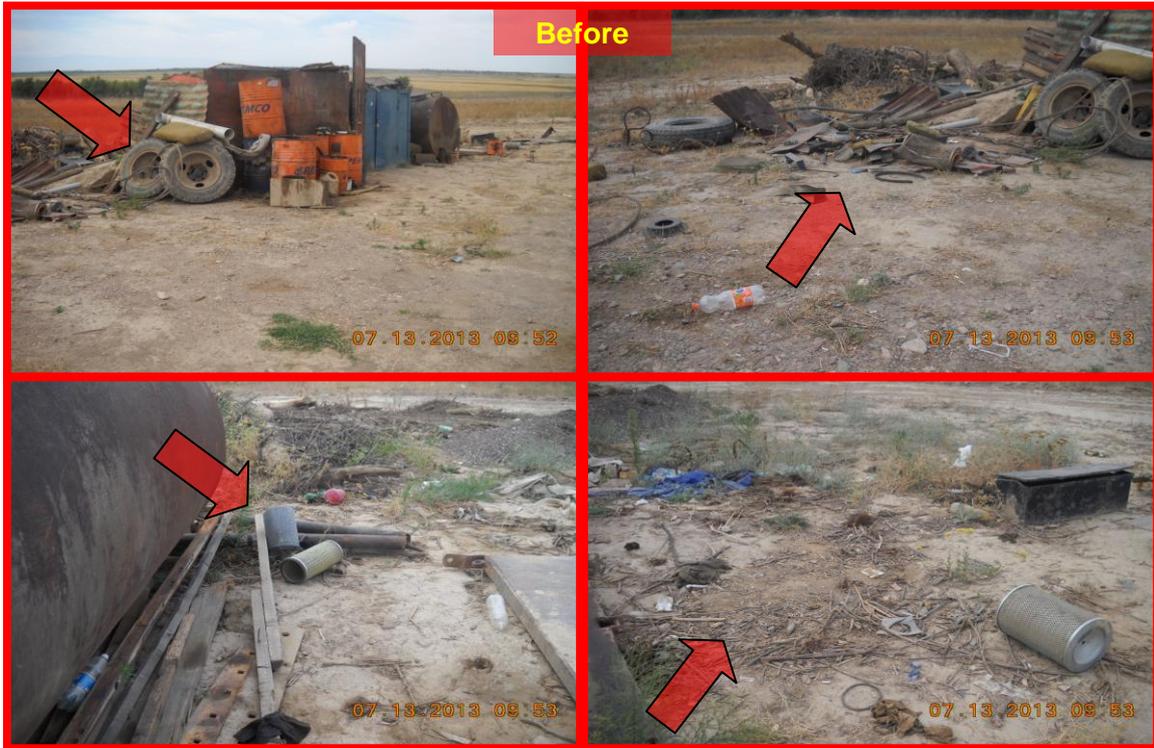
Photo No. 8 : Improper solid waste management at Almanty Instroi's Camp

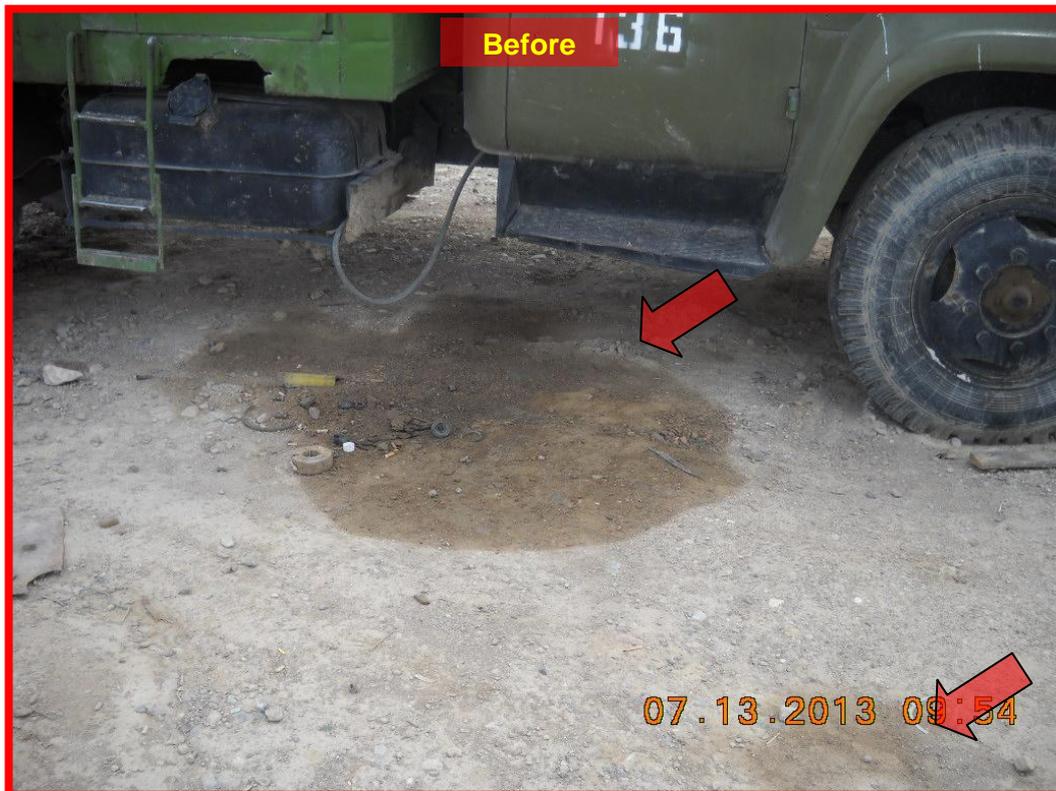
Photo No. 9 : Spilled diesel from truck at Almanty Instroi's Camp

The Contractor should instruct the subcontractor to avoid or minimize spills of petroleum liquids in the work camp.	Letter of violation as a warning should be issued by Contractor to his Subcontractor	Immediately
	<u>Exposed barrels causing contamination</u> – Traces of oil spill were found near the truck which could most probably occurred during truck maintenance [Photo No. 10]	Sub-contractor should scrap contaminated soil and dispose them appropriately.	For compliance by the Sub-contractor and supervised by the Contractor.	Immediately
		The Contractor should instruct the subcontractor to place barrels under shed and provide concrete pad underneath them	Letter of violation as a warning should be issued by Contractor to his Subcontractor	Immediately

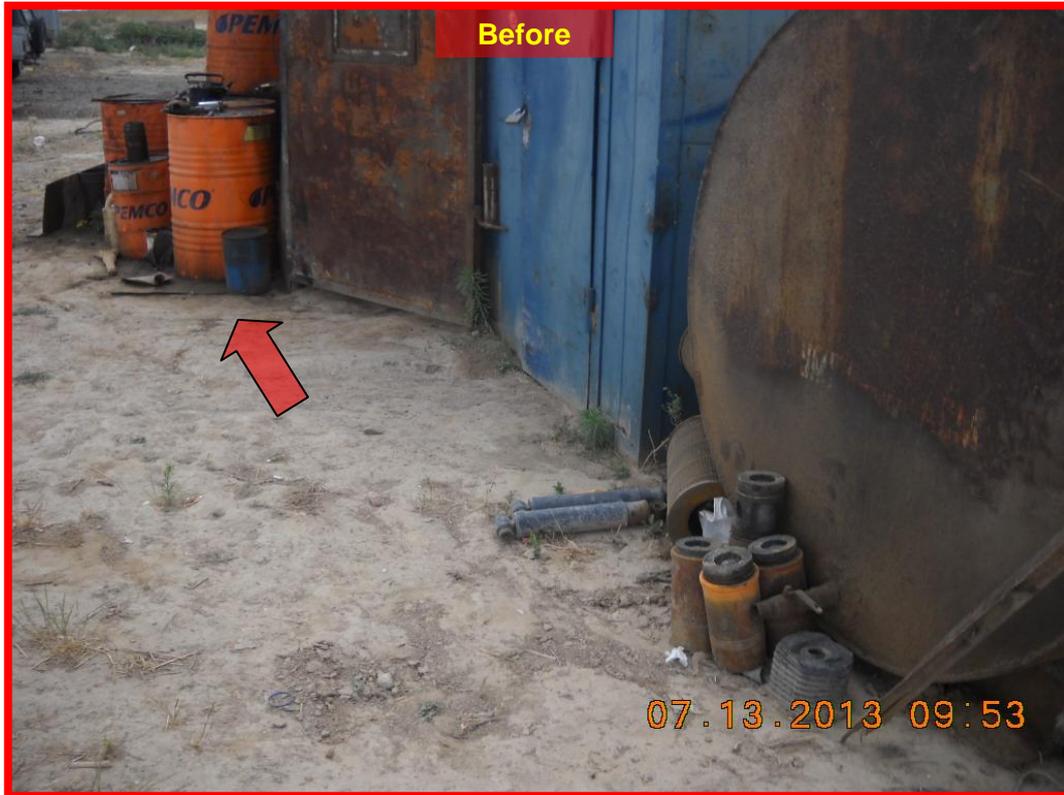
Photo No. 10 : Exposed barrels causing contamination

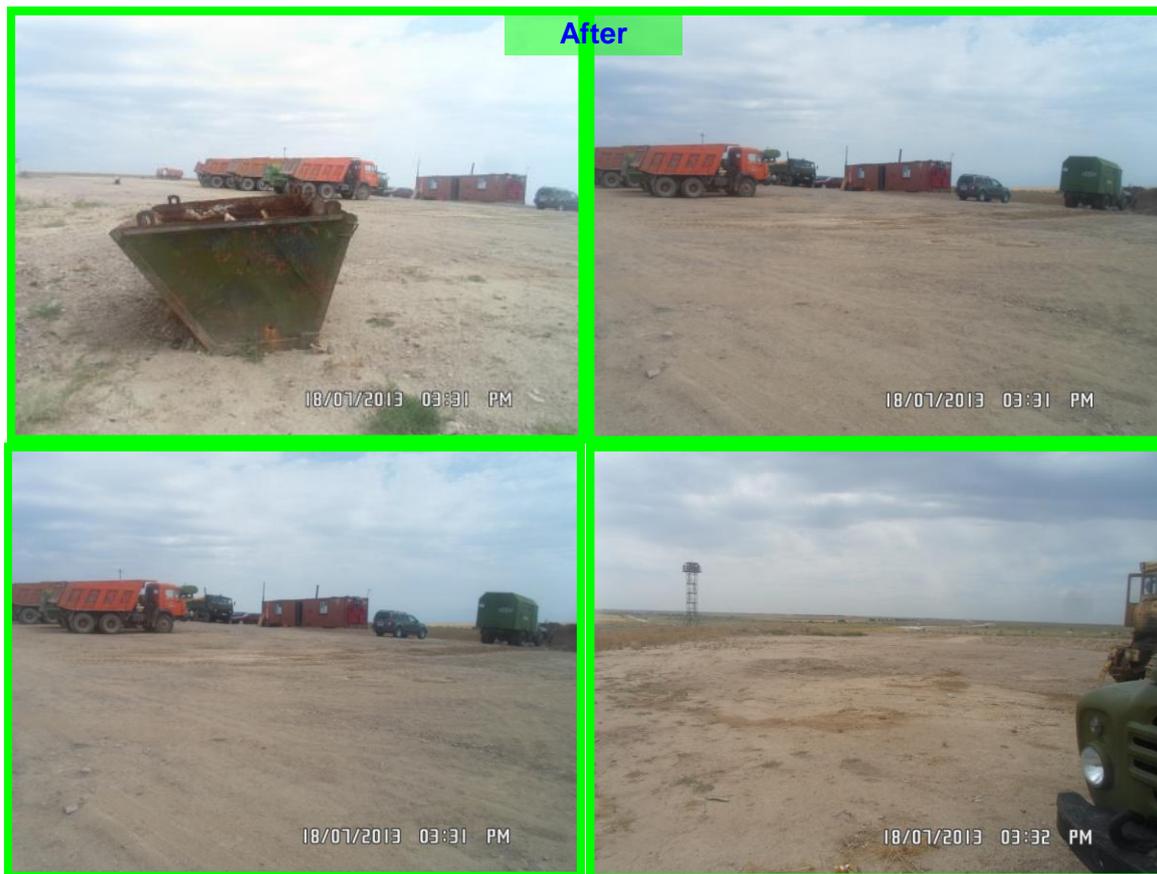
Photo No. 11 : After clean-up at Almaty Instroi's Camp

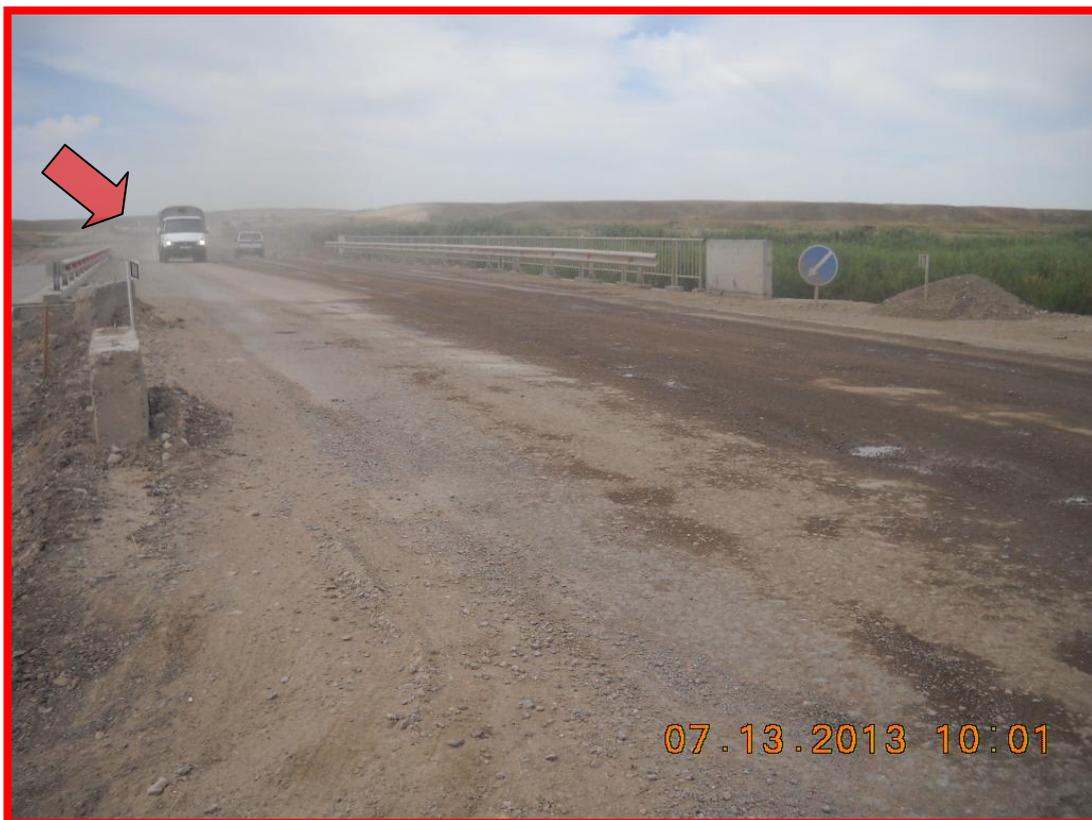
Photo No. 12 : Dust generation at the un-watered part of the road

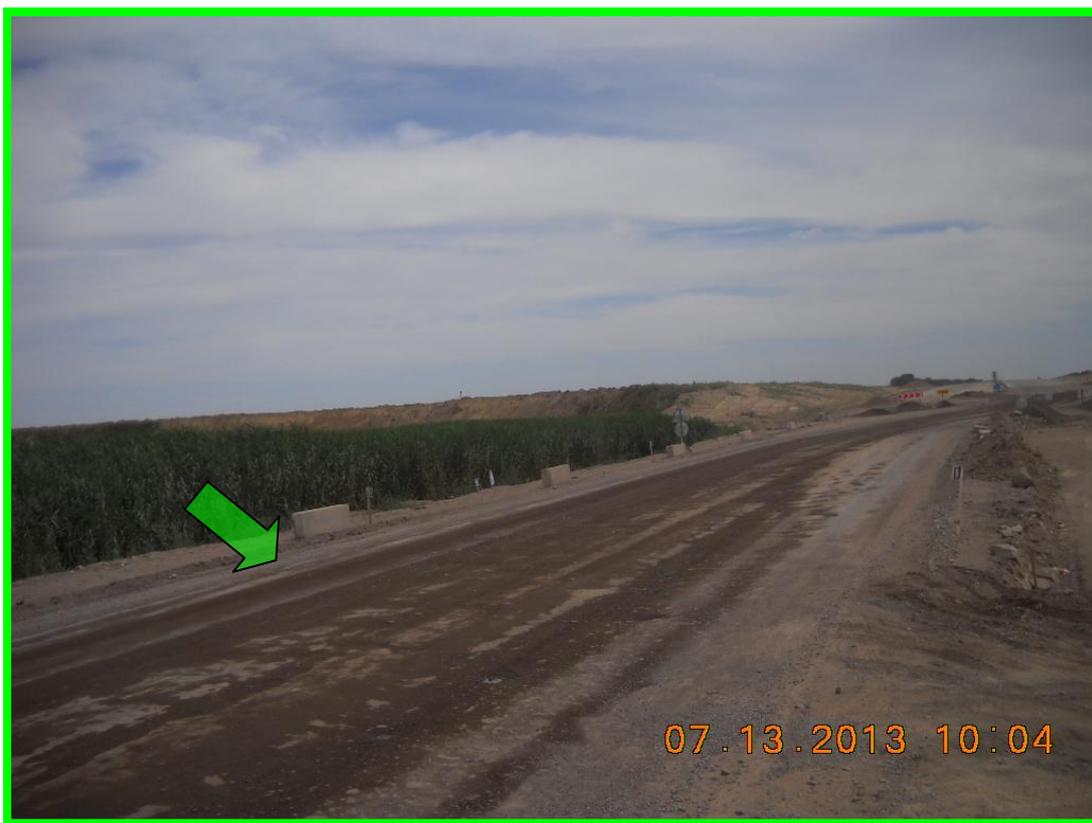
Photo No. 13 : Watered roadway

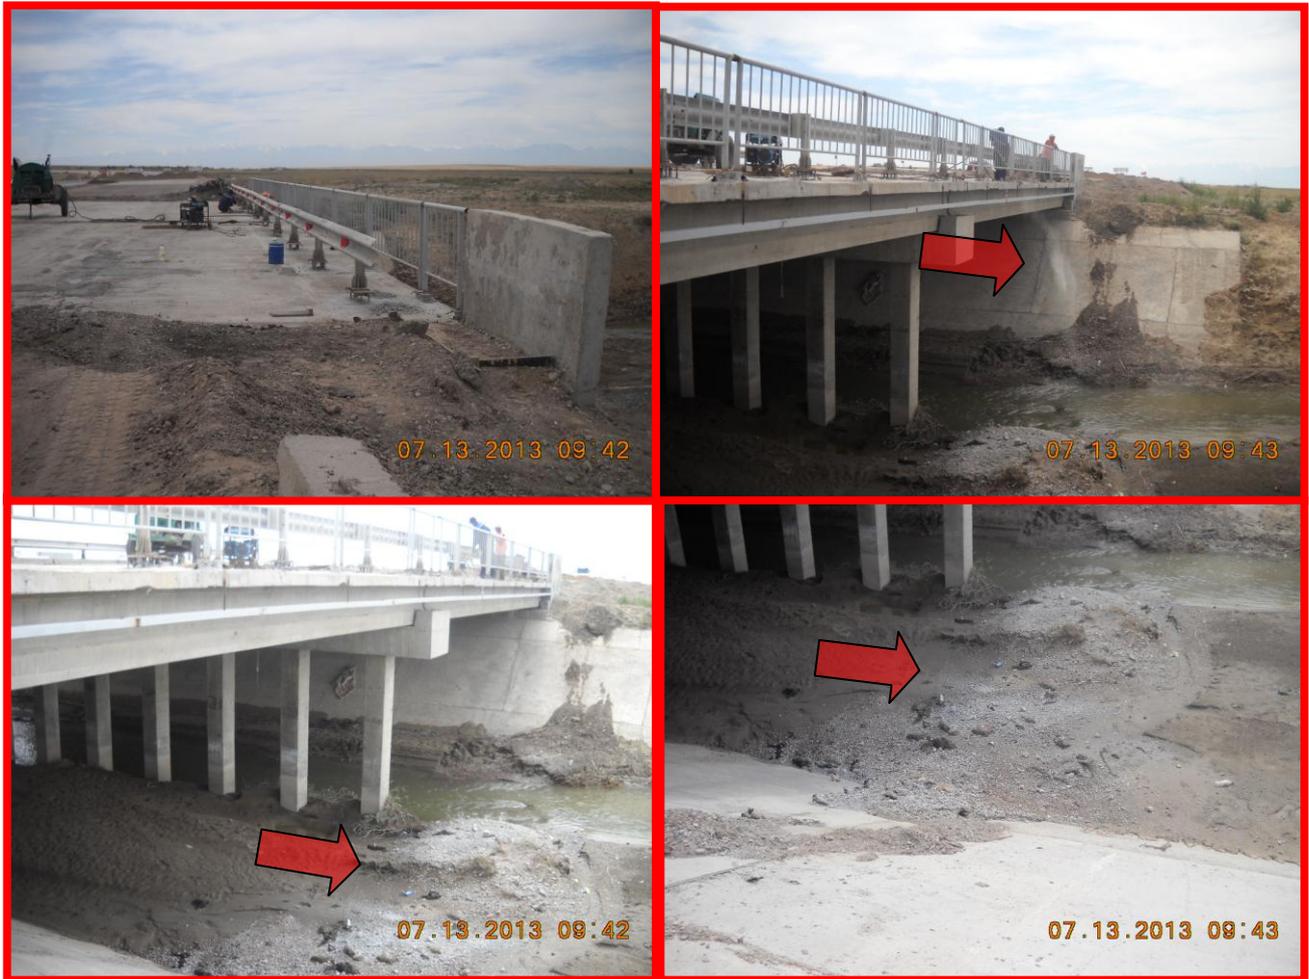
Photo No. 14 : Construction waste being thrown into the river at Karabalta River Bridge

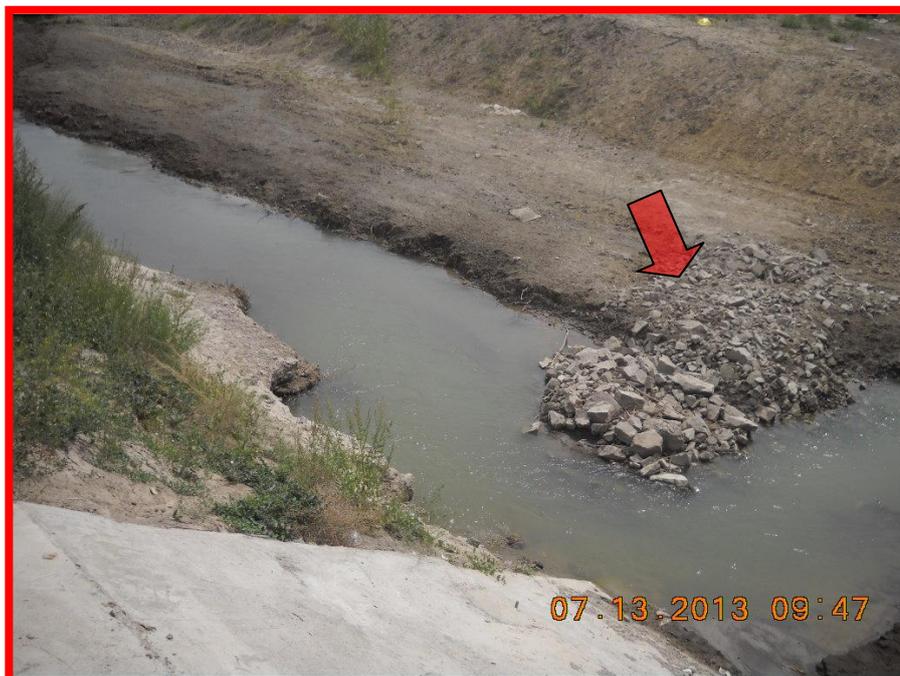
Photo No. 15 : Construction debris dumped into the Karabalta River and affecting flow direction

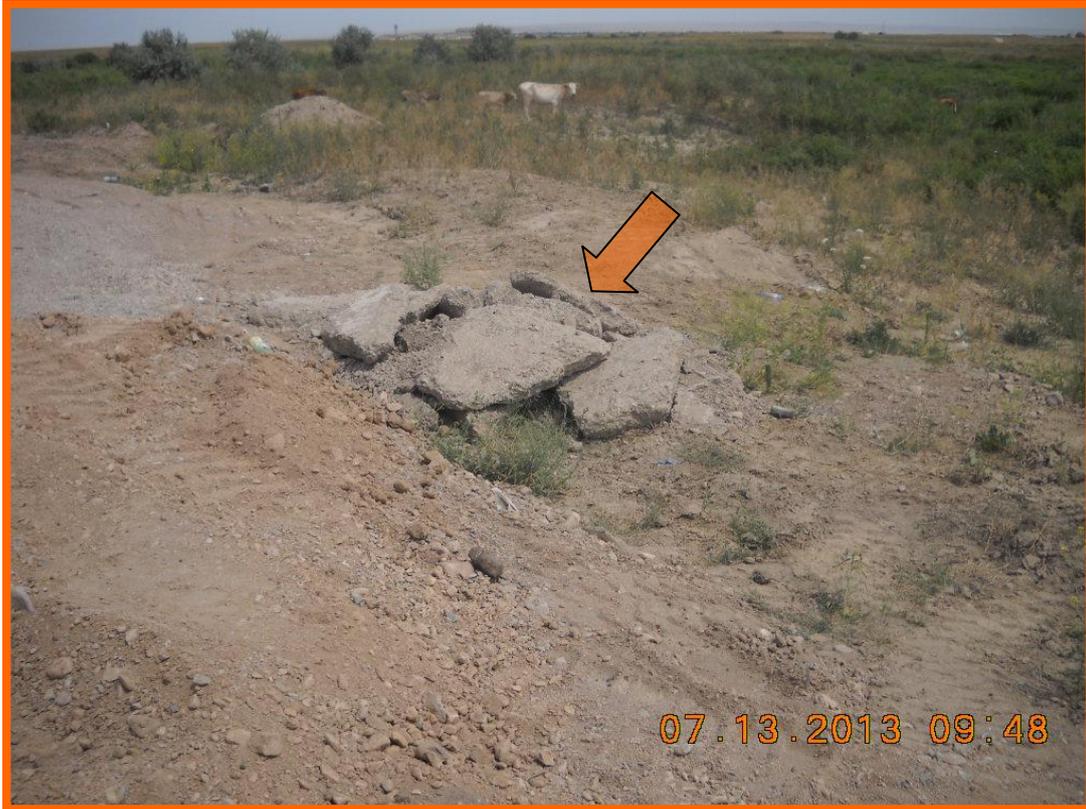
No.	Observations <sup>7</sup>	Description of Proposed Corrective Actions or Measures	Responsible Entities	Target Deadlines
8	<u>Demolition debris should be hauled away to approved places</u> – Debris from demolition were found along side the road. [Photo No. 16]	The Contractor should decide with the Employer the final disposal sites for these materials	For compliance by the Contractor to decide with Employer	Within the next Quarter
	<u>Removed old infrastructure should be placed in approved location</u> – Old structures removed during construction were put alongside the road [Photo No. 17]		CS Consultant to facilitate with Employer	
9	<u>Borrow Pit being operated by Contractor near km 261</u> – Borrow pit is being operated by the Contractor, extracting sand and gravel materials and transporting them to the washing equipment (See Annex C for permit). [Photo No. 18]	The basic requirement for opening and operating borrow pit is the obtaining of the permit. The Contractor said that permit is being processed	Contractor to present the permit once obtained	As soon as possible

Photo No. 16 : Demolition debris should be hauled away to approved places

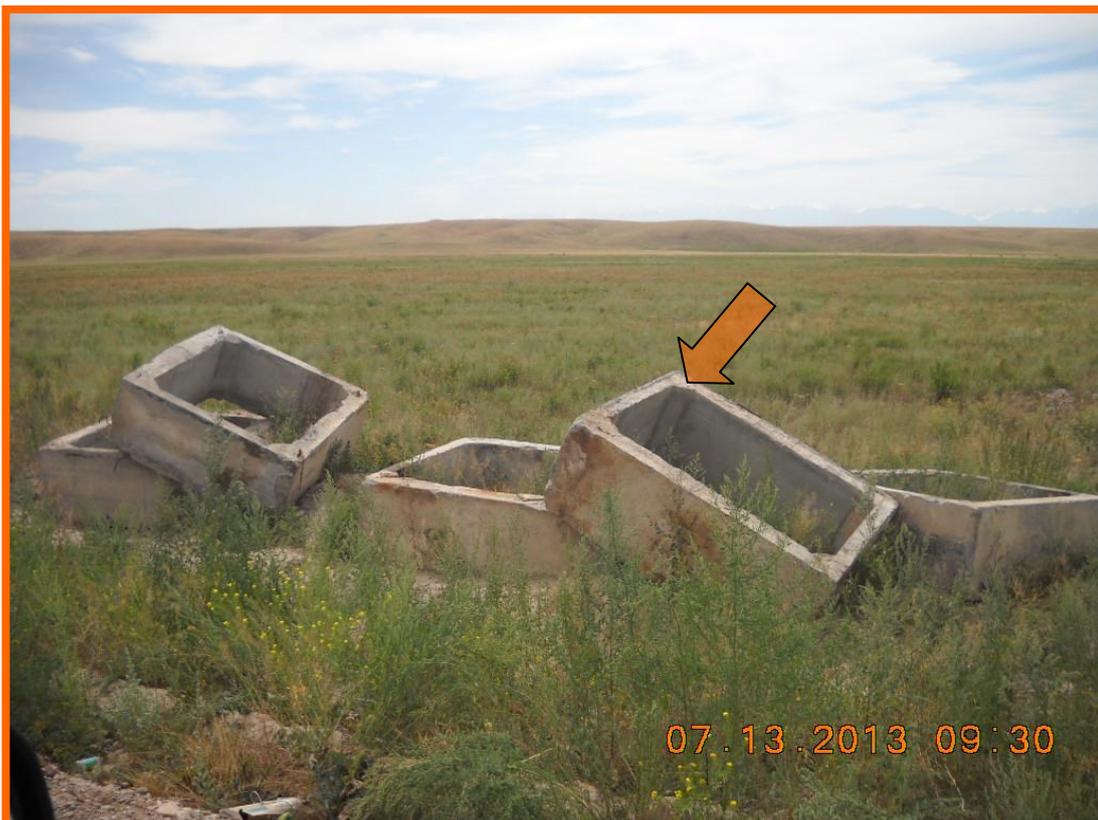
Photo No. 17 : Removed old infrastructure should be placed in approved location

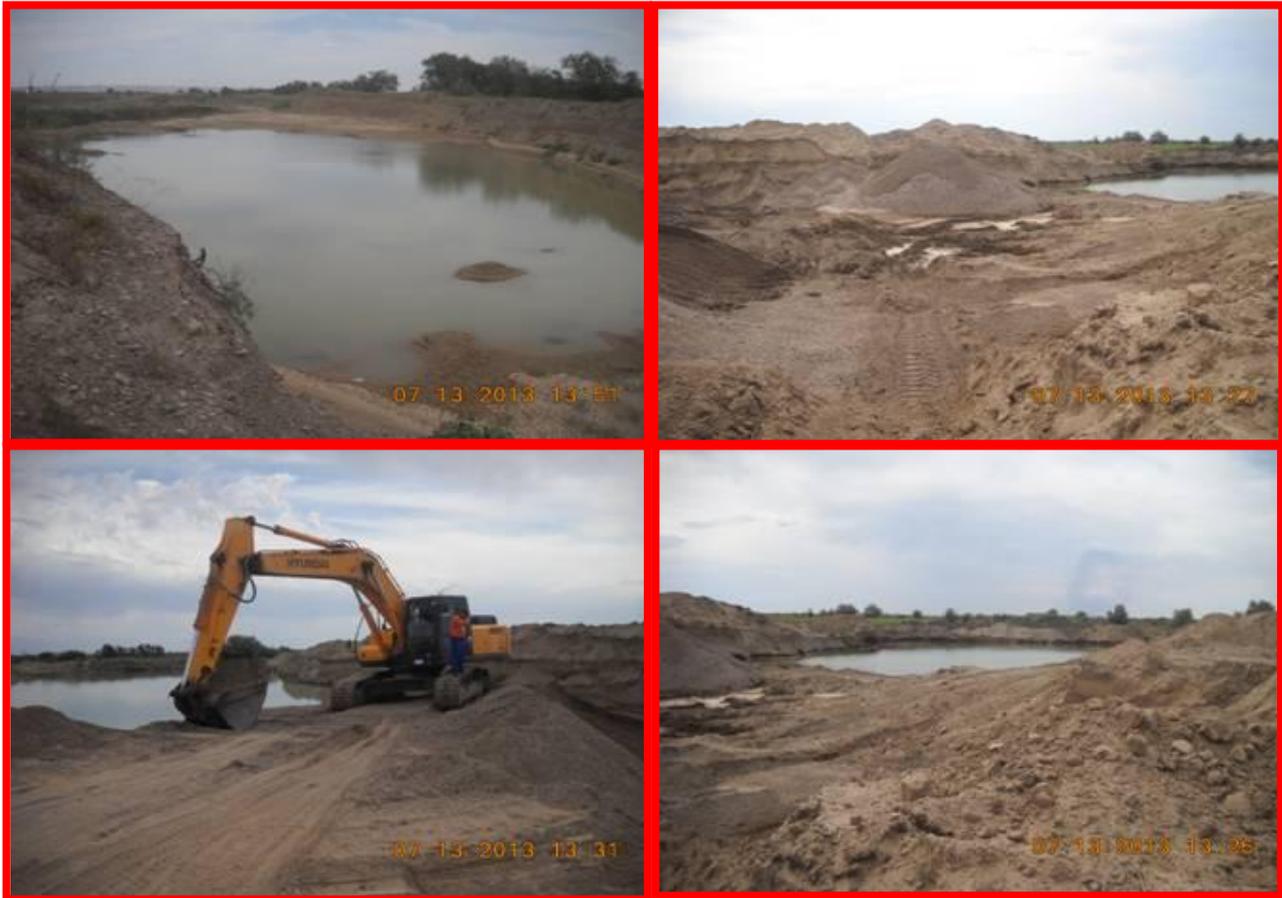
Photo No. 18 : Borrow Pit being operated by Contractor near km 261

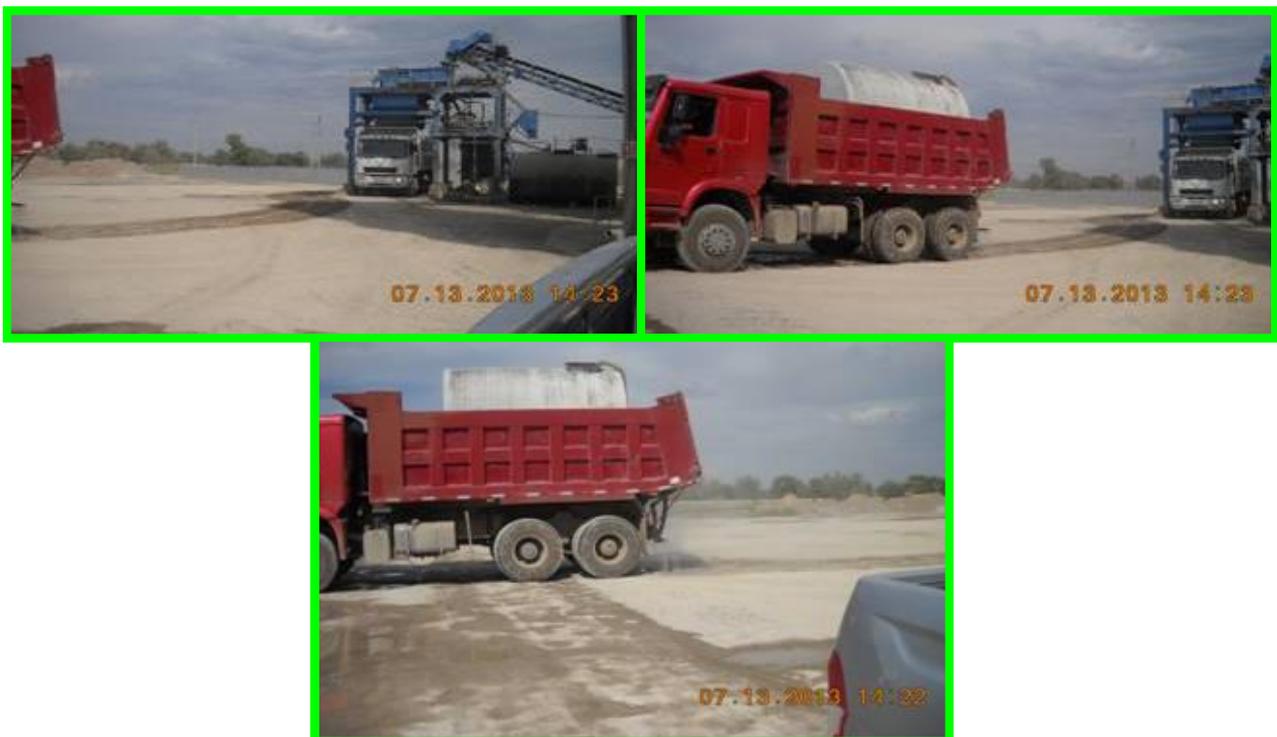
Reinstatement plan should be drafted by the Contractor	CS Consultant to review the reinstatement plan	After submission by Contractor
10	<u>Periodic watering activities at the cement concrete batching plant</u> – To suppress dust, the Contractor was spraying water on the grounds of the batching plant. [Photo No. 19]	Water spraying should be done regularly	For compliance by the Contractor	Daily
11	<u>Diesel spills at the fuel refilling area</u> – Spillage of diesel were found at the area where the diesel supply truck was stationed. [Photo No. 20]	Refilling equipment should be maintained to avoid spillage	Contractor to implement	Immediately
		Personnel should be instructed to avoid/ prevent spills when filling	CS Consultant – to monitor	Weekly Monitoring

Photo No. 19 : Watering to suppress dust at the cement batching plant near the camp

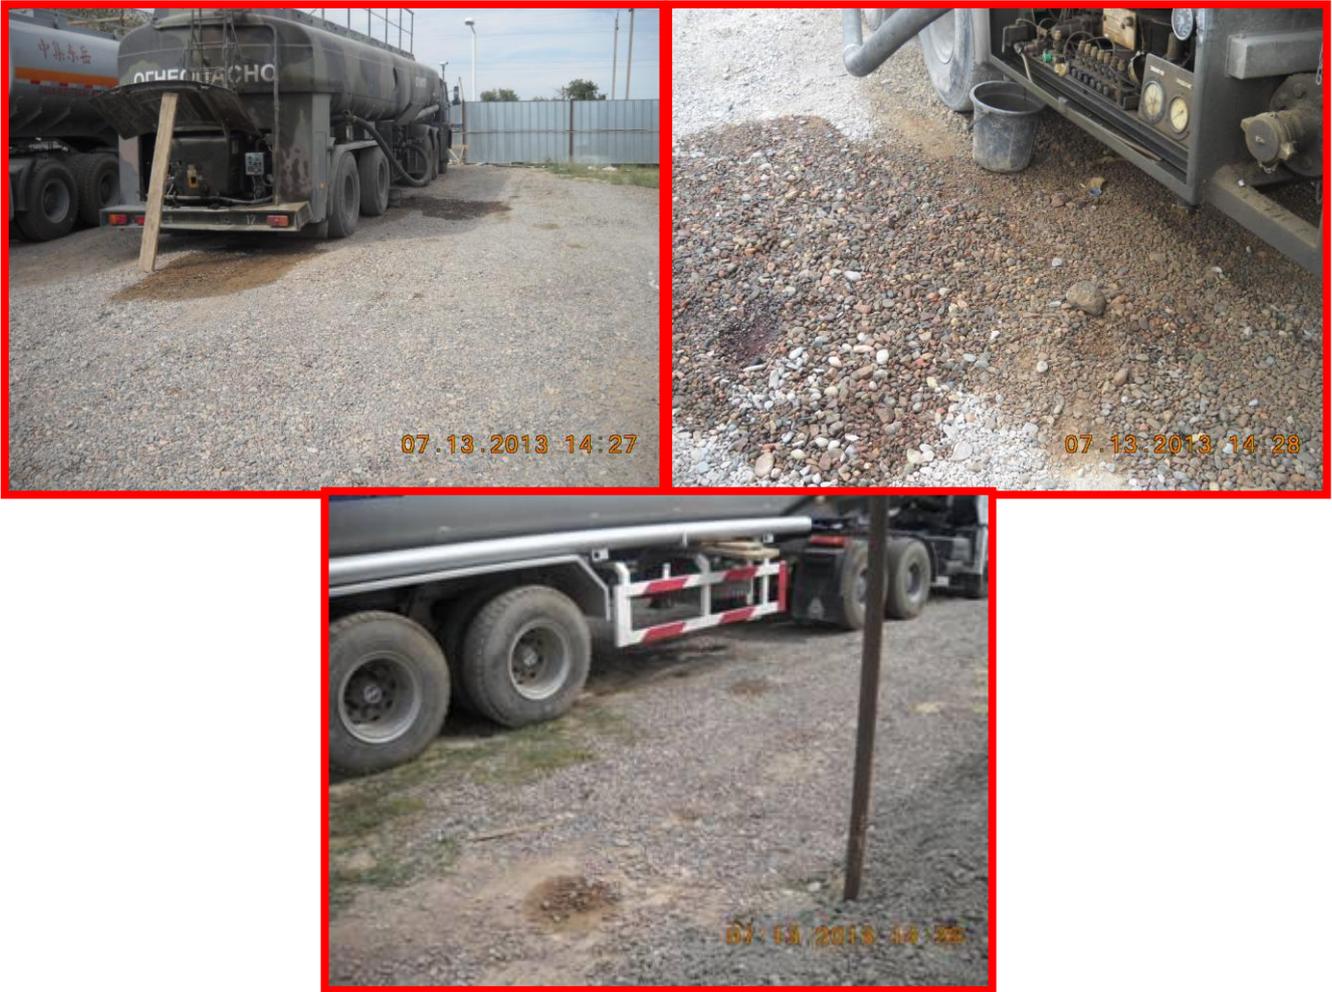
Photo No. 20 : Diesel spills at the fuel refilling area

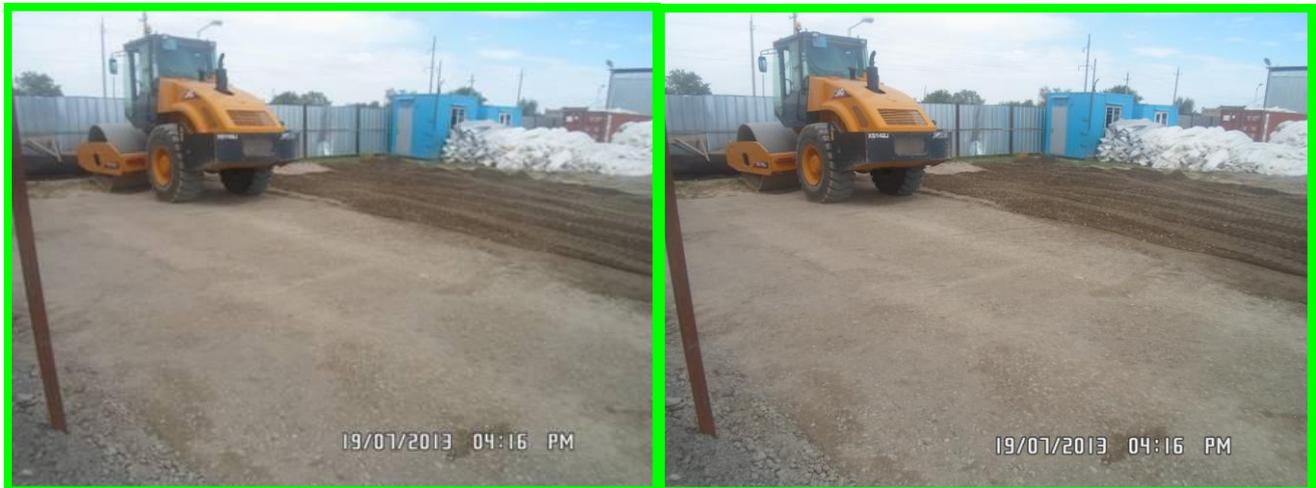
Photo No. 21 : Fuel refilling area being protected from contamination by lean concrete
