CONSTRUCTION SUPERVISION OF THE TARAZ BYPASS SECTION IN  
ZHAMBYL OBLAST, INVESTMENT PROGRAM PROJECT 5  
(ADB Loan # L2824-KAZ, MFF CAREC Transport Corridor I)

# BI-ANNUAL ENVIRONMENTAL MONITORING REPORT - Jan. 2014

# Bi-annual Environmental Monitoring Report

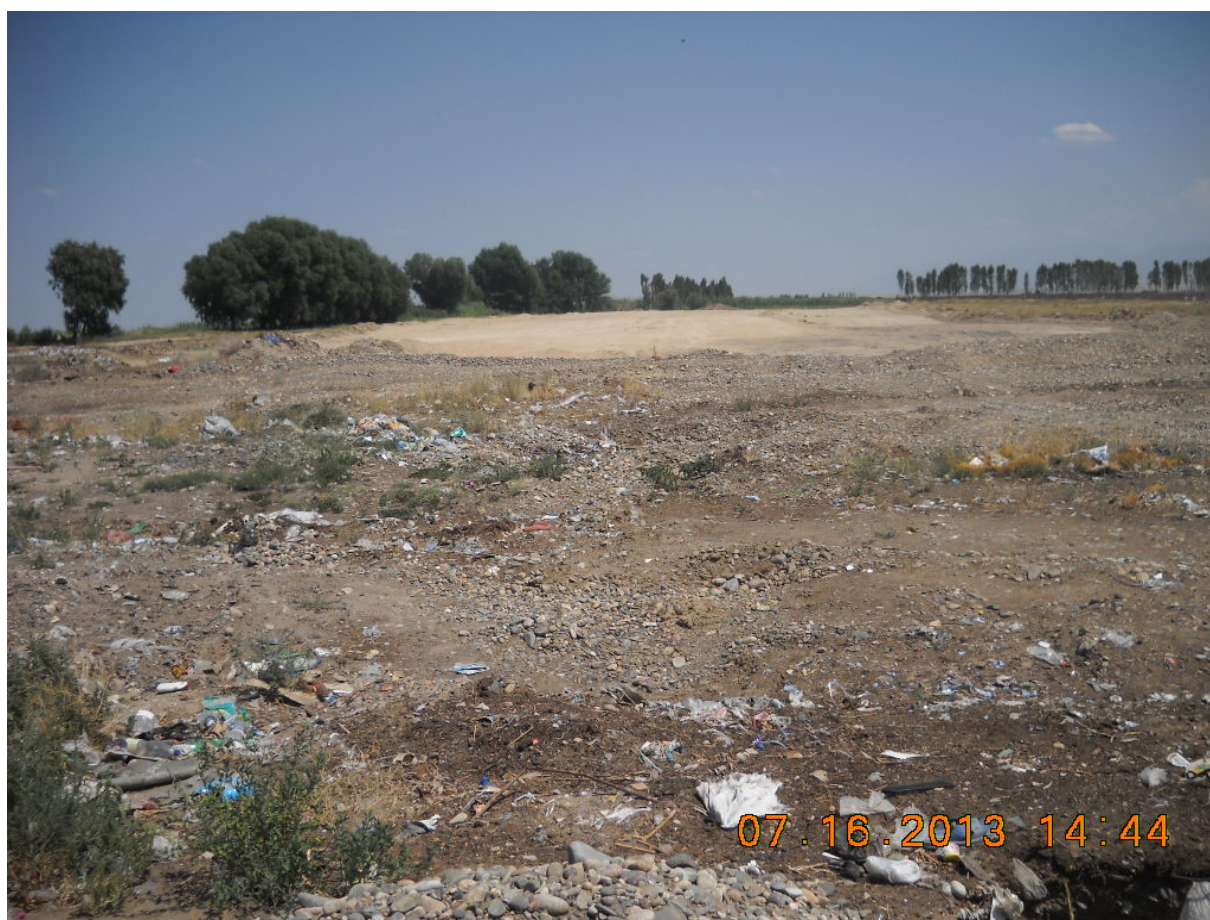
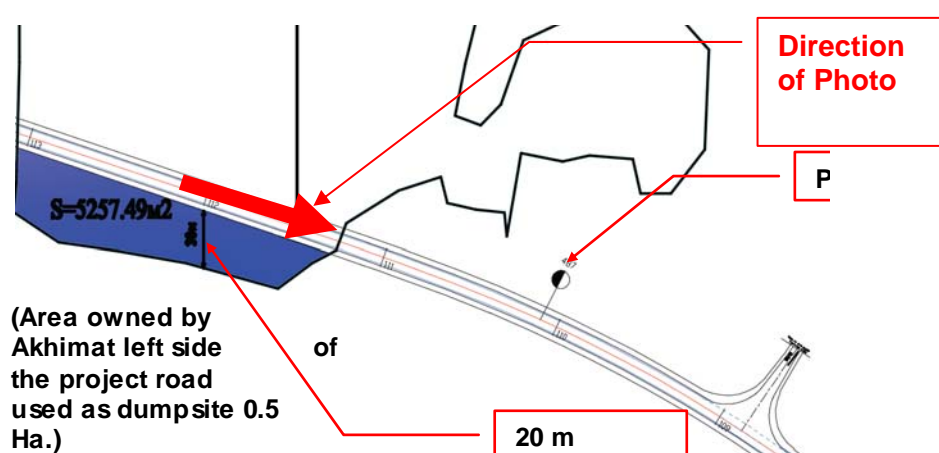
Figure 6: Layout of the Dumpsite with the Photo Project Road (1)

1. The dumped garbage materials were found outside of the property of the private dumpsite owner.
2. The road's alignment actually runs through the property of the Akhimat. Hence, the garbage materials were illegally dumped within the Akhimat's property.
3. Based on Contractors' survey, the property line of the private dumpsite is around 350 m to the right edge of the road. The Akhimat's property was divided in one big portion at the right-hand-side and small portion at the left-hand-side. The distance from the left edge of the road to the edge of the Akhimat's property at the left-hand-side is around 20 m. (see attached map and photos).
4. The perceived plan as of now is to task the Contractor to move the garbage out of the Road Right-of-way (ROW) into the adjacent areas. Whatever garbage that will remain at the

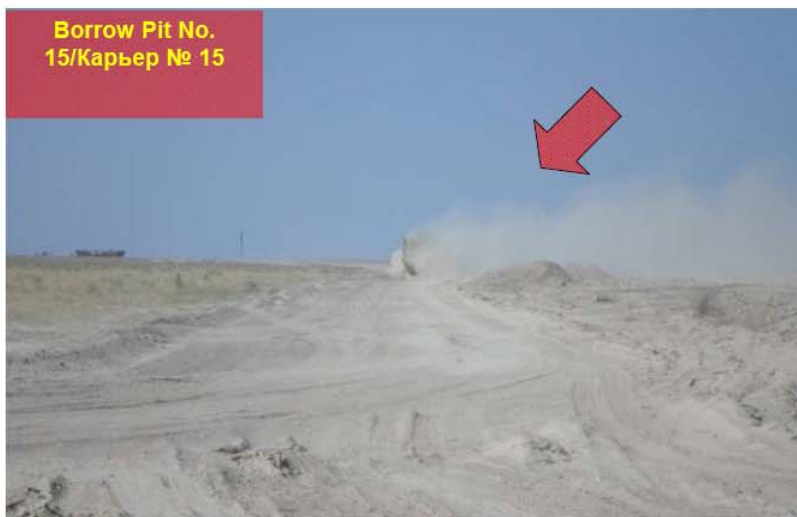
**UNCOVERED DUMPTRUCKS WHEN TRANSPORTING SOIL/  
САМОСВАЛЫ, НЕПОКРЫТЫЕ ПОЛОГОМ ПРИ  
ТРАНСПОРТИРОВКЕ ГРУНТА**

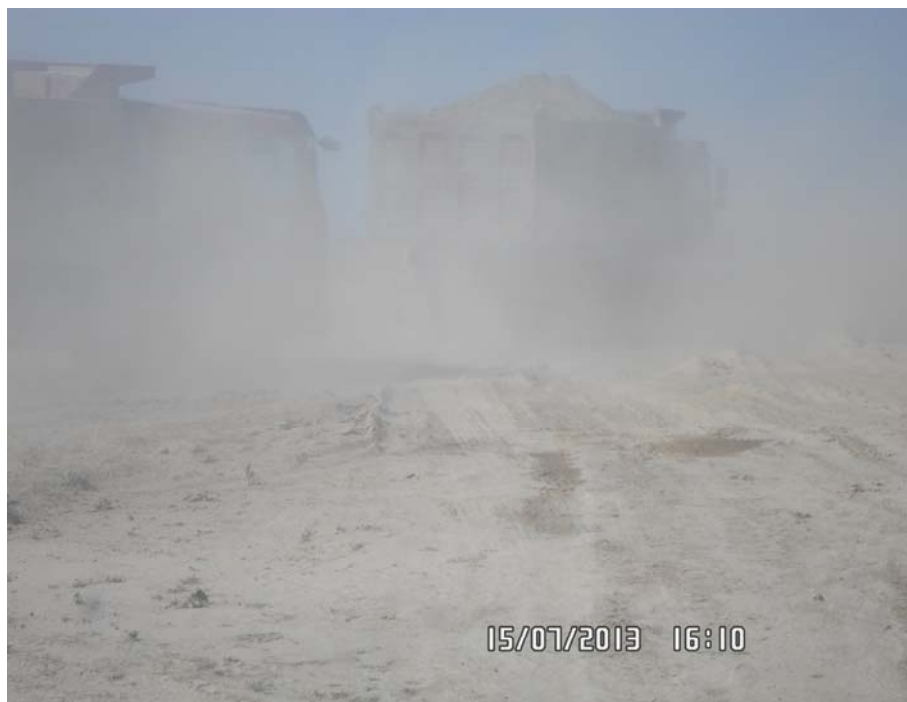
No.	Description of EHS Issue	Description of Proposed Measures
1	<u>Excessive Dust at the worksites</u> – During dry periods, excessive dust was generated by traffic of trucks and equipment. This is can have short and long term health impacts to workers. (Photo No. 1)	The Contractor should water the work area more frequently in dry periods to minimize the generation of dust, in compliance with the environmental requirements.
2	<u>Trucks without cover</u> – A number of dumptrucks of the Contractor or subcontractor are without cover and containment barrier. This can be hazardous as these trucks run in local roads as well. (Photo No. 2)	The Contractor should inspect all dump trucks are equipped with cover and containment barriers to avoid any accidents along the road and to prevent any materials from dropping from the trucks.

**Photo No. 1:** Excessive dust at the worksites

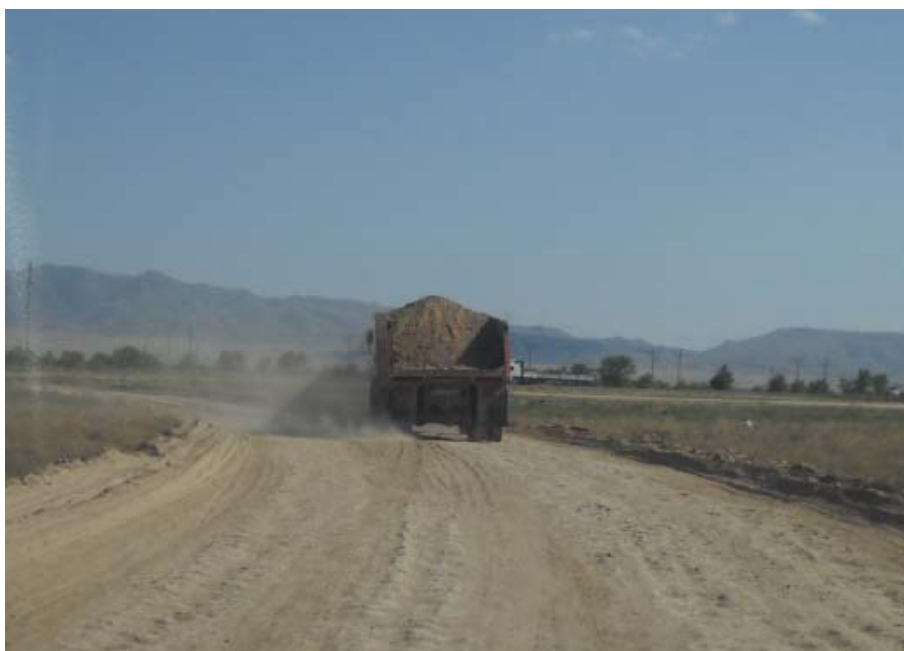
**Photo No. 2:** Truck without cover

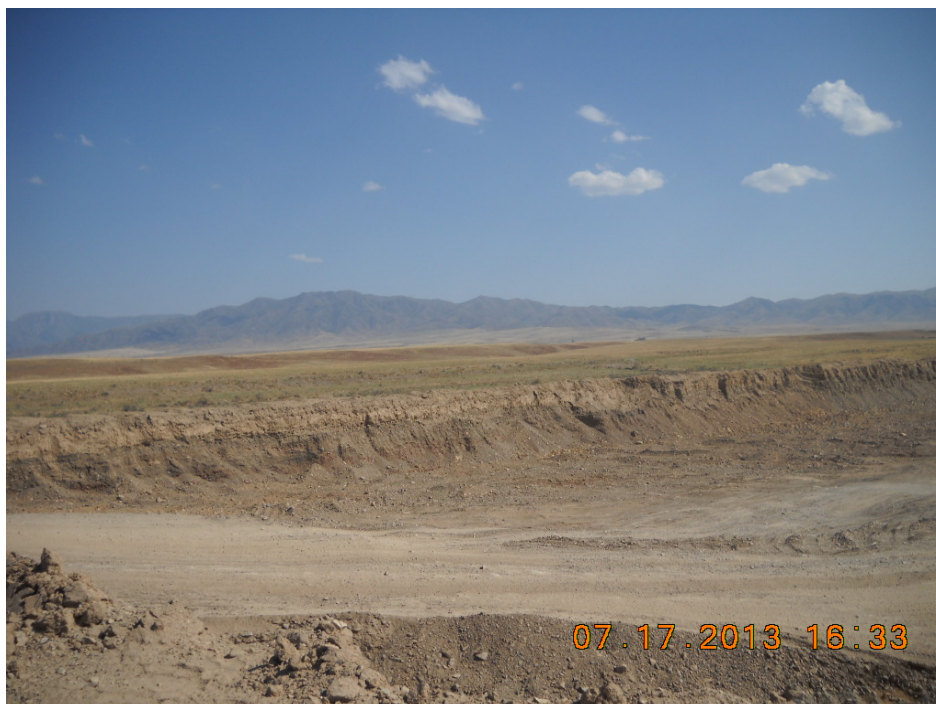
No.	Description of EHS Issue	Description of Proposed Measures
3	<u>Reinstatement Plan needed for borrow pits</u> – The project uses a number of borrow pits for road embankment. Excavation without plan would lead to difficulty in reinstating the sites. (Photo No. 3)	The Contractor should formulate and submit to the Engineer a Reinstatement Plan for all borrow pits. Implementation of the plan shall be prior to demobilization.
4	<u>Improper handling of oil/lubricants</u> – Lubricants and oil during maintenance of equipment are spilled on the ground. This leads to ground contamination and eventually groundwater contamination. (Photo No. 4)	The Contractor should instruct his subcontractors to avoid contamination of the ground and handle oil/lubricants properly.
5	<u>Workers without proper Personnel Protective Equipment (PPE)</u> – Workers were not wearing helmets and work boots. (Photo No. 5)	The Contractor should instruct his subcontractors that PPE should be worn at all times at the work place to minimize accident and health hazards.

**Photo No. 3:** Borrow Pits should have Reinstatement Plan

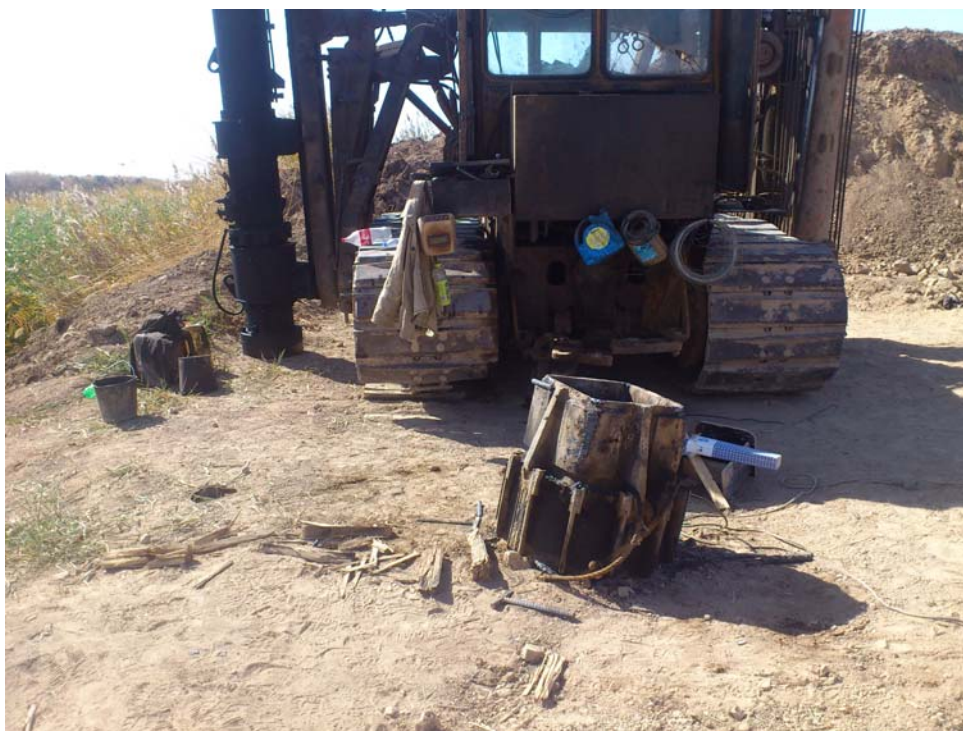
**Photo No. 4:** Improper handling of oil/lubricants

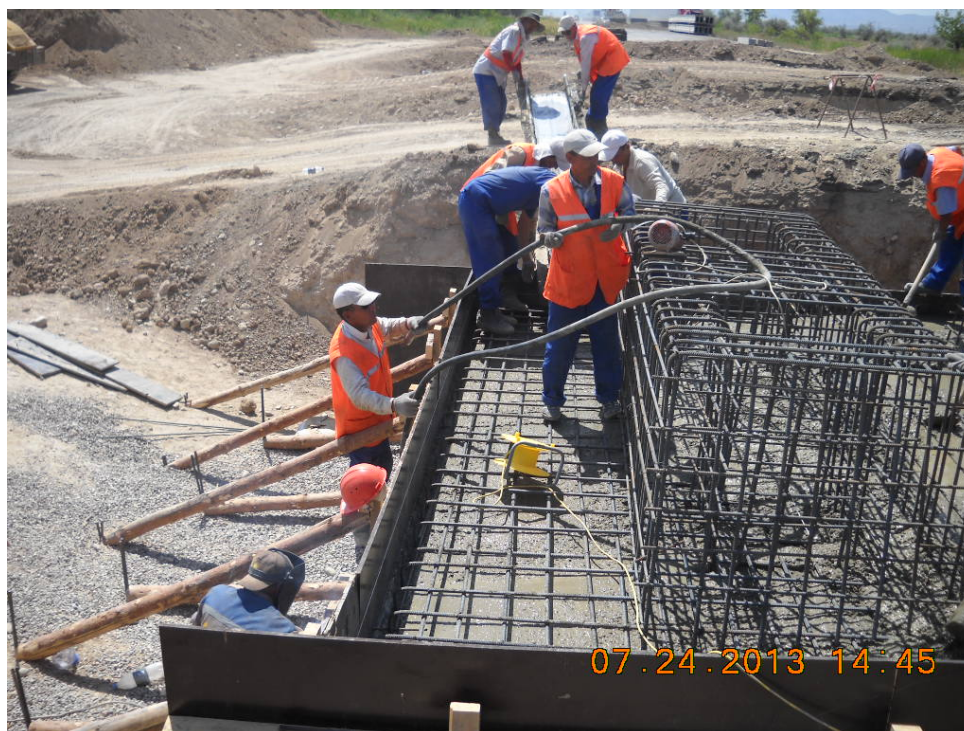
**Photo No. 5:** Workers without proper Personnel Protective Equipment (PPE)

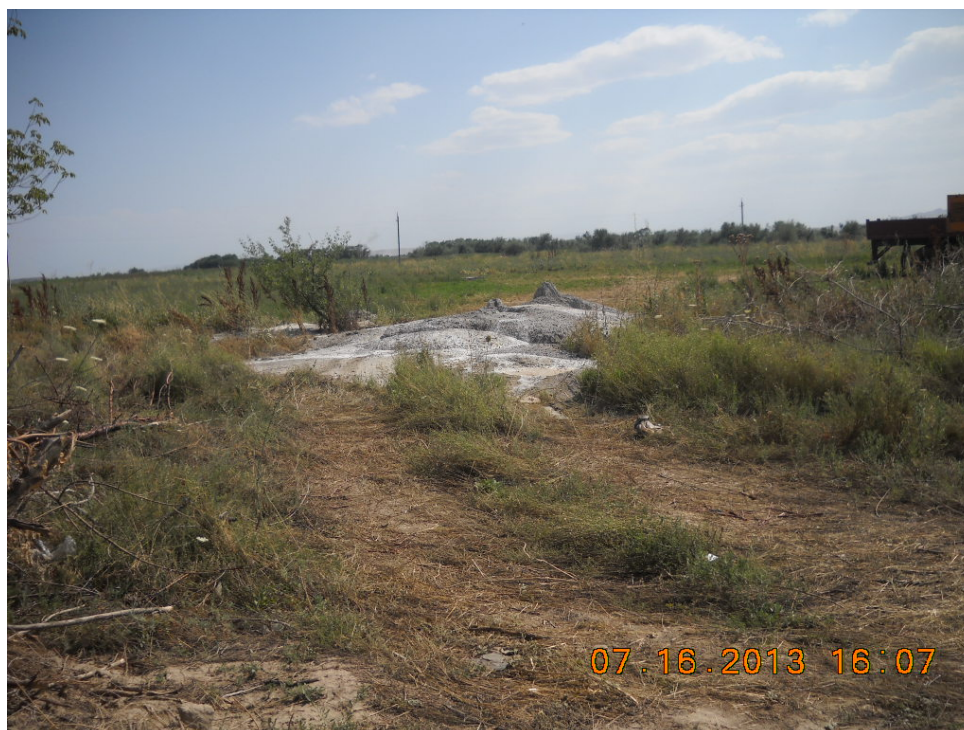
6	<u>Dumping of excess concrete at Asa Interchange worksite</u> – Excess concrete cement mix was found to have been dumped in the surroundings. (Photo No. 6)	The Contractor should inform his subcontractors not to dump any excess concrete just anywhere. All un-permitted dumping should be removed by the Subcontractors.
7	<u>Bitumen reservoir without secondary containment</u> – Bitumen reservoir does not have containment works around it, such that any spill gets directly into the ground and contaminate the soil and eventually groundwater. (Photo No. 7)	The Contractor should construct secondary containment system to eliminate the risk of spill onto the ground.
8	<u>Accumulation of garbage at the quarry &amp; crusher site</u> – Garbage have been accumulating at the site, resulting in unsanitary condition. (Photo No. 8)	The Contractor should regularly haul away garbage to improve the sanitary condition of the worksites.

**Photo No. 6:** Dumping of excess concrete at Asa Interchange worksite

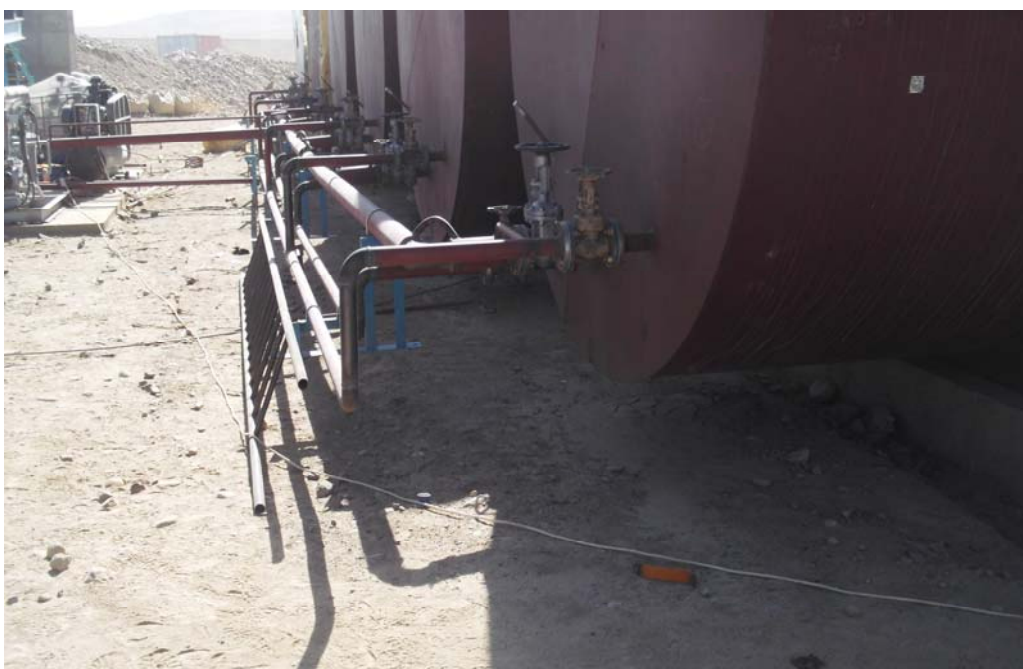
**Photo No. 7:** Bitumen reservoir without secondary containment

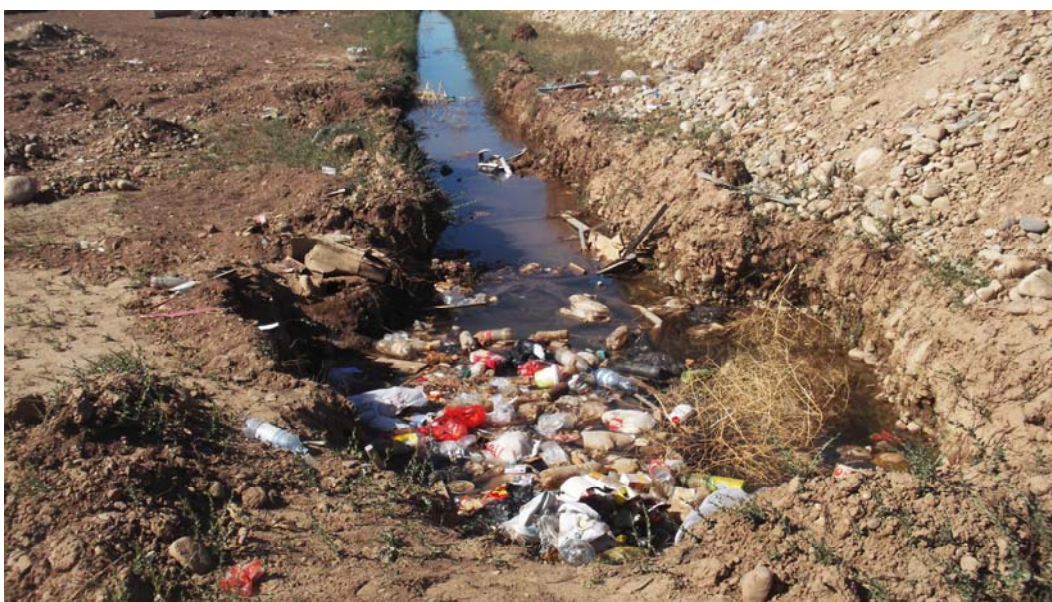
**Photo No. 8:** Accumulation of garbage at the quarry & crusher site
